Unit ID **Gas turbine**
 Component **Lubricating oil**
 Current sample number **1700834**

Machine type: **Gas turbine**
 Manufacturer: **ABC**
 Oil brand name: **Mobil DTE 832**
 Oil quantity in system: **4300 l**

Example report
 Analysis scope: Turbine Oil Kit 7

Diagnosis for the current laboratory values

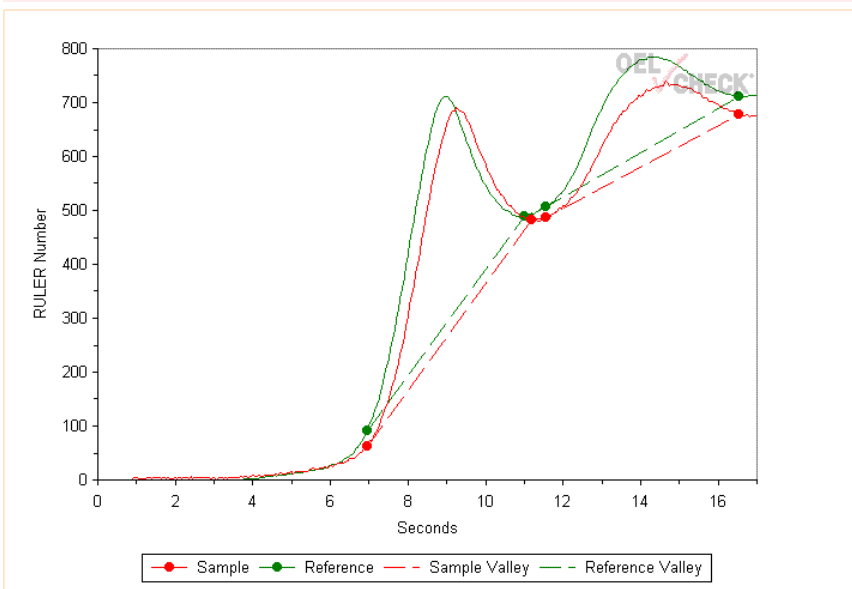
Antioxidant/RULER		
Antioxidant 1 - RULER	%	91,3
Antioxidant 2 - RULER	%	84,7

In comparison with the reference sample, there are no significant changes of antioxidant additives (oxidation inhibitors).
